Navajo Abandoned Uranium Mine

Site Screen Report

Montezuma No. 1 AUM Site

January 2011

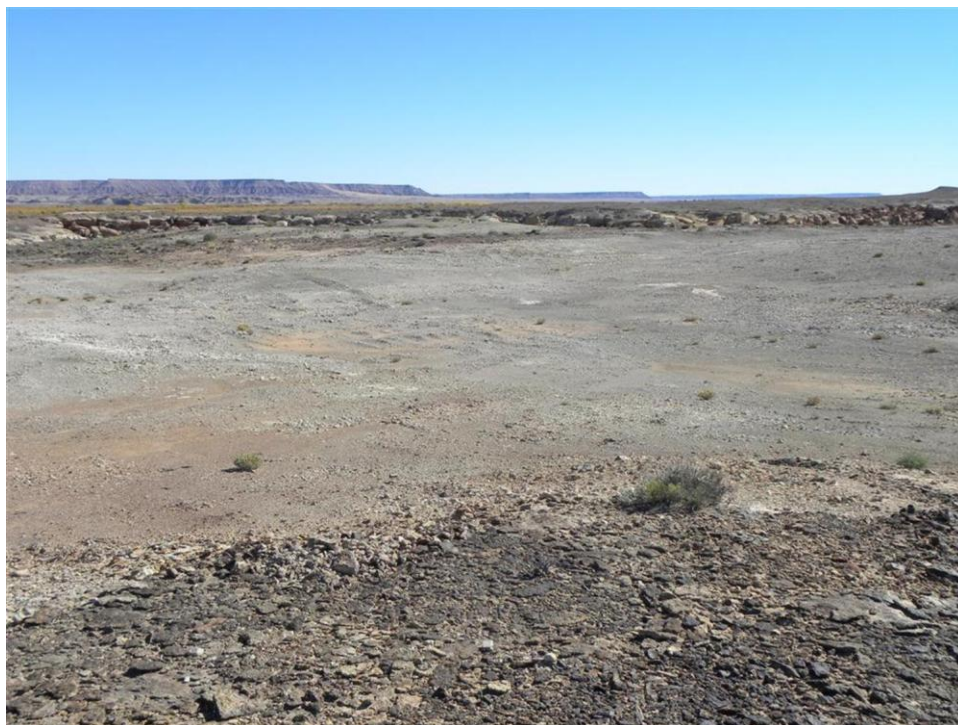
Photo 1. Montezuma No. 1 mine site

Large reclamation cap, grey stone pushed over small cliff, 120' x 100' x 30', above stream; apparent mining operations in nearby sidewall

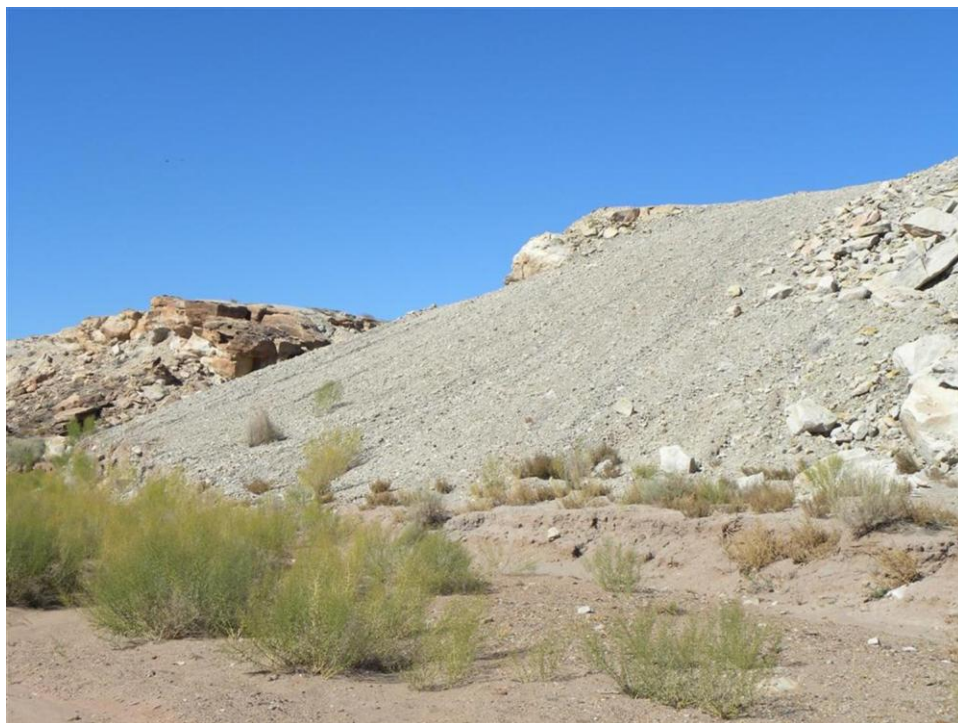
Photo 3. Montezuma No. 1 mine site, reclamation cap

Yes (large reclamation cap)

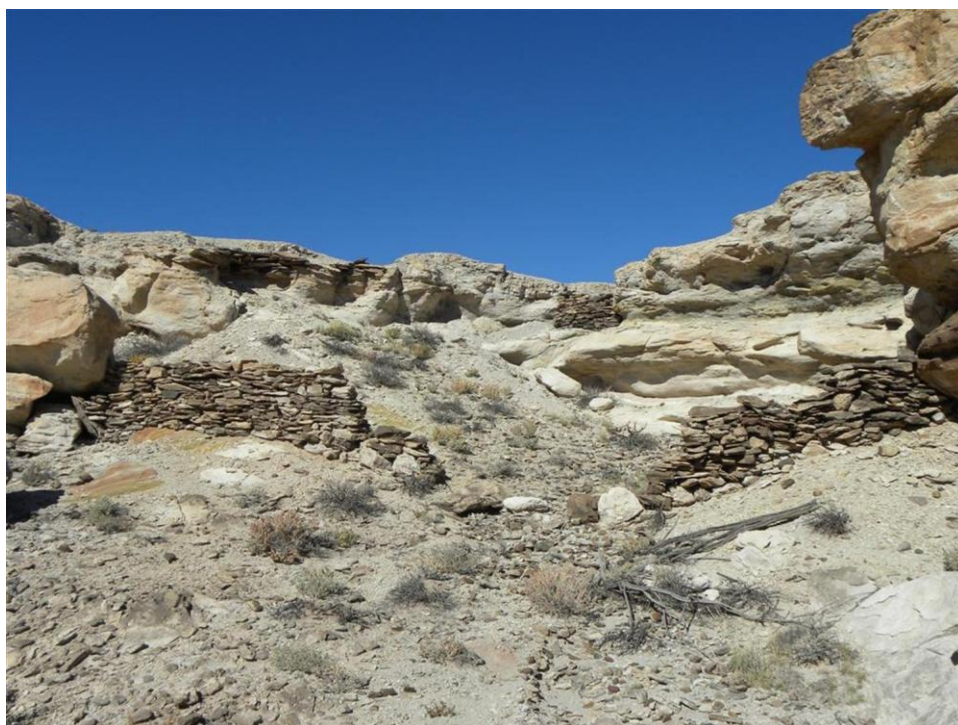
Photo 4. Montezuma No. 1 mine site, apparent camp area

A total of 1,976 gamma radiation measurements were collected from the mine site, ranging from 8,217 cpm to 30,788 cpm. The measurements collected in the apparent camping area to the east of the site were found at a maximum level of approximately 20,000 cpm. The measurements are represented in Figures 1 and 2.
